Horizontal Drains on California Highways

Smith, T.W. and G.V. Stafford

State of California  
Department of Public Works  
Division of Highways

**HORIZONTAL DRAINS ON CALIFORNIA HIGHWAYS**

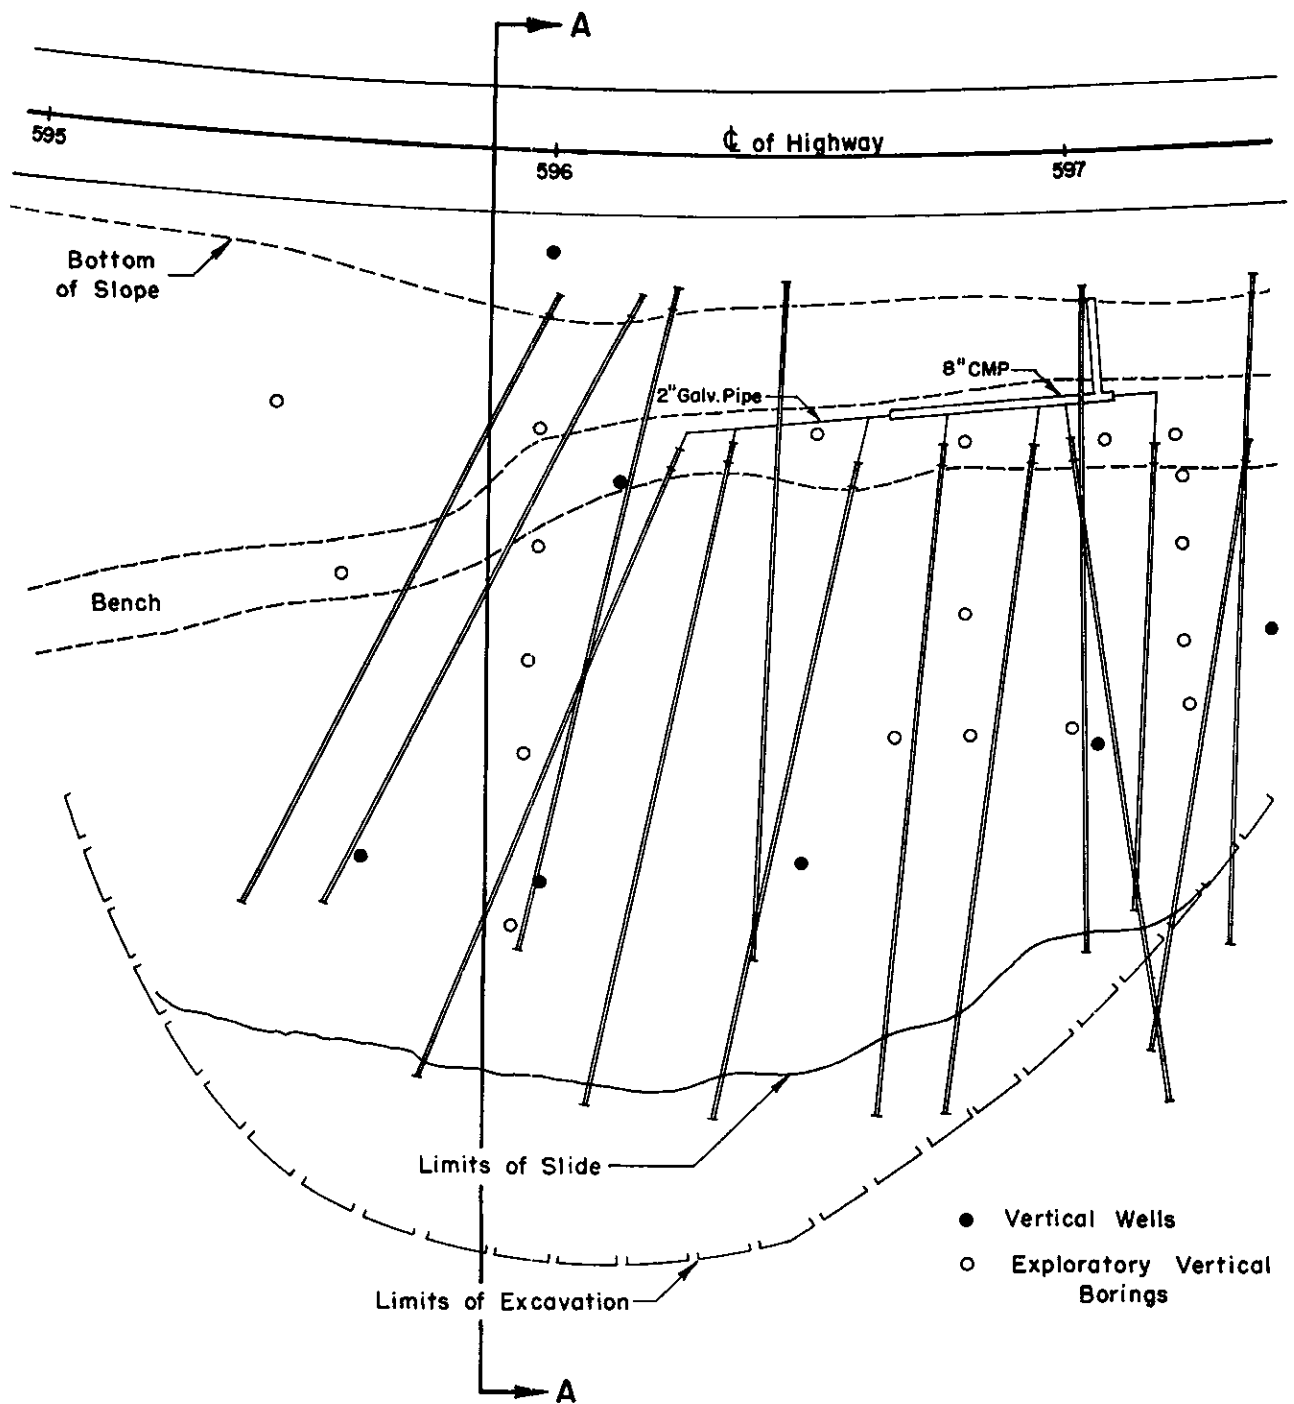
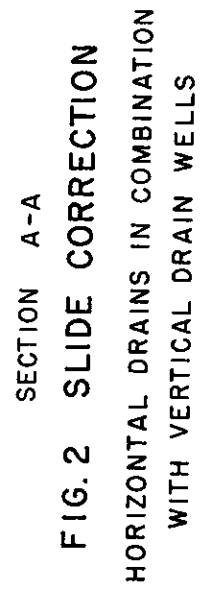
**FIG.1 SLIDE CORRECTION**  
**HORIZONTAL DRAINS IN COMBINATION**  
**WITH VERTICAL DRAIN WELLS**

This slide occurred in the right side of a thorough cut which was constructed in 1947. This cut is  $2\frac{1}{2}$  miles south of Willits on U.S. Highway 101. Seepage was noted in the cut slope during construction, but was not alarming in view of the planned slopes of 2:1. However, in the winter of 1948 three small slides developed and were smoothed up by maintenance forces. During the winter of 1950 the slide again became active, probably because of the exceptionally heavy rainfall that year. The amount of seepage water was much greater than previously observed and the sliding was more extensive. A break joining the three previous slides developed much higher on the slope and a plastic movement of the entire mass created a traffic hazard by encroaching on the traveled way every winter until the installation of 17 horizontal drains in 1953. See Figs. 1, 2 and 3.

The location and depth of the ground water, together with the topography will determine the locations from which the drains will be started. Since the drains will remove the water from the area by gravity, the starting point for a drain must be below the elevation of the point where water is to be intercepted. An exception to this idea would be the relief of excess hydrostatic pressure by a combination of vertical wells and horizontal drains. (Figs. 1, 2 & 3).

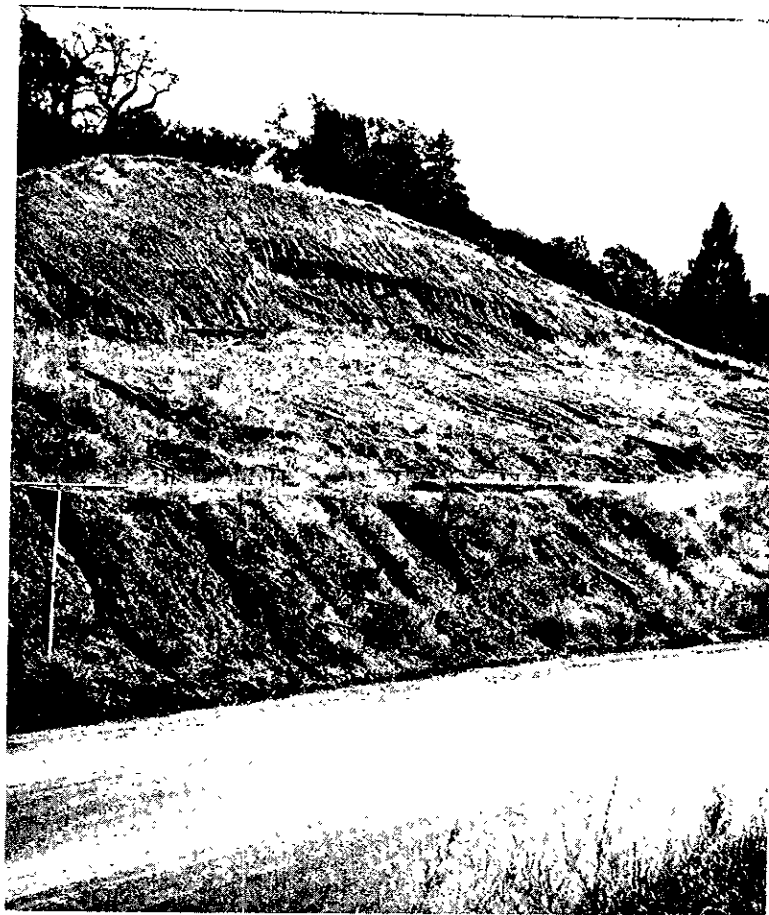
Fig. 3. Slide condition corrected by vertical wells and horizontal drains (see Fig. 1 & 2).

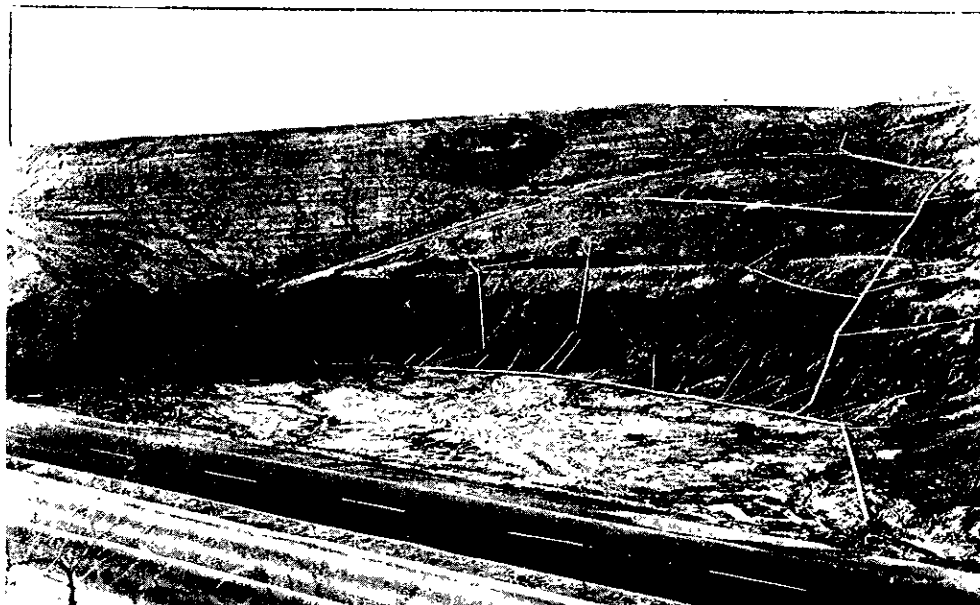
Fig. 4. Completed drain installation and collector pipe system.

One other important consideration in planning a drain installation is a collection pipe or system to carry the intercepted water out of the critical area. (Fig. 4). If the outlet of the drains discharge into an existing gutter, usually no other steps are taken. If this is not the case, some other means is used. Access is provided at the lower ends of the drains for future inspection and cleaning.

The most satisfactory installation has been the use of 6" to 8" galvanized CMP. The drain outlets are connected to the larger CMP which in turn collects the water from the drains and carries it to any desired location outside the slide area, such as a natural surface channel.
